Surface Analysis of Stressed and Control Tin Oxide Thin Films on Soda Lime Glass

*Presented at the National Center for Photovoltaics and
Solar Program Review Meeting
Denver, Colorado
March 24-26, 2003*

Surface Analysis of Stressed and Control Tin Oxide Thin Films on Soda Lime Glass NCPV and Solar Program Review 2003

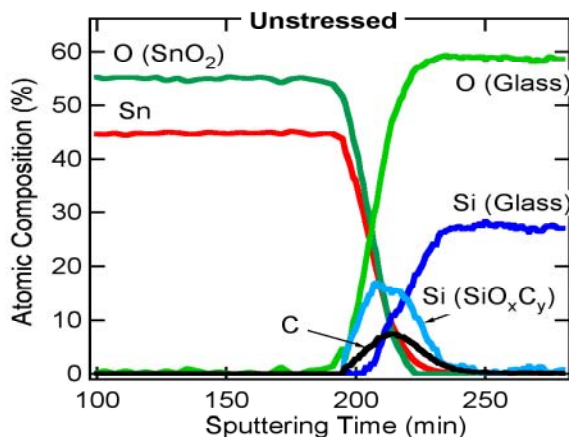
Figure 1 shows the XPS depth profile for a commercial sample of tin oxide/glass that was not subjected to the above-described stressing procedure. The y-axis displays atomic concentration of the corresponding elements, and the x-axis is sputter time in minutes. Through proper calibration of the instrument, this axis may alternatively be plotted as thickness. An initial survey scan of this sample revealed only tin, oxygen, and adventitious carbon within the first 50-100 Å of analysis depth. The tin oxide layer is estimated to be over 8000 Å, and, consequently, only tin and oxygen are determined for the first 190 minutes of sputter time. Due to the thickness of the tin oxide and its uniform composition, the first 100 minutes of the profile are not shown in Fig. 1. One peak for oxygen 1s photoelectrons derived from oxygen in tin oxide is observed at a binding energy of 530.6 eV. As the sputter crater reaches a depth wherein photoelectrons from additional oxygen-containing layers are detected, a second broad O1s peak begins to appear. This peak is centered at 533.0 eV and is well resolved from the tin oxide oxygen peak. By using oxygen 1s scans from the beginning and end of the depth profile, linear least squares analysis (LLS) is used to fit the two forms and then plot the corresponding contributions from these forms as a function of sputter time. The peak at 533.0 eV is due to photoelectrons from oxygen in glass as well as oxygen in the silicon oxycarbide layer in proportions dependant on sputter depth. Photoelectrons from oxygen in both the glass and silicon oxycarbide layer occur at a higher binding energy than oxygen in tin oxide due to their more electropositive environment compared to their environment in tin oxide; and assignments are consistent with literature values.[4] Using a smaller pass energy on the XPS analyzer in future studies may resolve the glass and oxycarbide oxygen forms.

Figure 1. XPS depth profile of control sample

The profile for the stressed sample in Fig. 4 is markedly different from the control profile in Fig. 1. First of all, the interfacial regions are not as sharply defined as in the control. Although the sample was stored in desiccant by EPV, it is possible that the delamination process has started. The degree to which this has potentially occurred would depend on a multitude of variables, including desiccant condition, threshold levels of humidity required for delamination, and exposure time to ambient prior to loading the sample in the instrument etc. A previously compact tin oxide layer that deteriorates and detaches from the SiO_xC_y layer or along with SiO_xC_y with the creation of voids would explain the qualitative differences in the tin profiles. Unlike the control sample, the stressed sample does not exhibit two distinguishable silicon components as tested by TFA. This means that even though Si 2p photoelectrons may arise from multiple silicon-containing species, all the silicon atoms exist in indistinguishable valence states or chemical environments, resulting in one peak centered at about 103.2 eV. This indicates that there has been a chemical breakdown of the silicon oxycarbide diffusion barrier, and the extended window over which carbon detection occurs may be an indication of a deterioration of SiO_xC_y physical

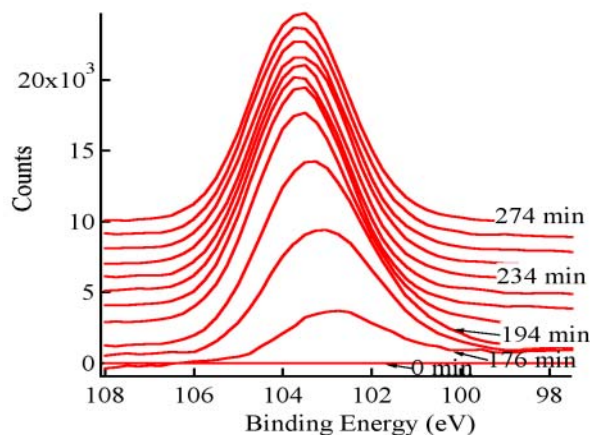
Occurring almost simultaneously with the appearance of the second oxygen peak in the depth profile was the appearance of silicon, which persisted throughout the completion of the depth profile. Unlike the oxygen spectra, the silicon spectra did not have two well-resolved components. Rather, the peak seemed to shift from 103.0 eV at the onset of detection, to about 103.6 eV as bulk glass was approached. Figure 2 shows a stack plot of selected silicon spectra as a function of increasing sputter time. Target factor analysis (TFA) was conducted to determine that two individual silicon species were responsible in varying proportions for the peaks – one centered at 103.0 eV occurring early in the profile, and the other at 103.6 eV dominating later in the profile. In TFA, principal component analysis (PCA) is first used to determine the number of component spectra required to reproduce the original spectra data within a certain amount of experimental error. In the next stage, spectral target factor analysis is performed to test each suspected component spectrum from the profile itself. Finally, once all the component spectra are identified, TFA will display the atomic concentration of each component as a function of sputter time. Figure 3 illustrates the two silicon-containing components determined by TFA for this depth profile. By displaying the resultant silicon components in the depth profile, the silicon species at 103.0 eV appears within a distinct window in the profile from about 180 to 230 minutes and is clearly due to Si in SiO_xC_y . The assignment of this component to Si from SiO_xC_y is further substantiated by the appearance of carbon within this same window (see below). The second Si-containing component at 103.6 eV begins to appear at about 210 minutes and eventually dominates the silicon species throughout the rest of the profile. This species is clearly due to Si in glass. The binding energies of these two Si peaks are consistent with the local chemical environments of Si in SiO_xC_y vs. Si in glass and is consistent with literature values.[4,5] Within the same window of sputter time that the SiO_xC_y silicon peak dominates, a single carbon peak centered at 284.0 eV also appears, consistent with carbon from SiO_xC_y . The Si (glass) peak is accompanied by the appearance of the alkali metal components of glass (Na, Mg and Ca), which are not shown.

Figure 2. Silicon stack plot

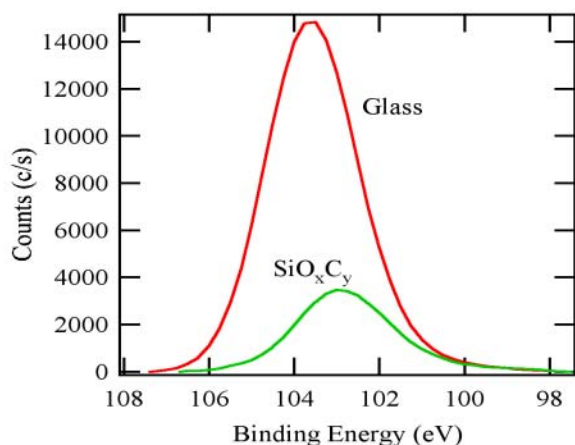
Figure 3. Principal silicon components (control)

Of particular interest in the samples was the clear indication of the silicon oxycarbide layer. Over the course of the profile for the non-stressed control sample, target factor analysis revealed two unique silicon-containing components. The lower binding energy component coincided with the appearance of a carbon peak within the same sputter time window, and this lower energy Si component was assigned to Si from the silicon oxycarbide layer. Somewhat later in the profile, a higher binding energy form of Si begins to dominate the Si signal and is assigned to Si from glass. Identification of the diffusion barrier layer in the control was found to be critical toward comparing this same layer in stressed samples where an apparent physical and chemical breakdown of the diffusion barrier seems to occur. This breakdown is believed to be a critical event during interfacial failure that ultimately may enable the delamination event.

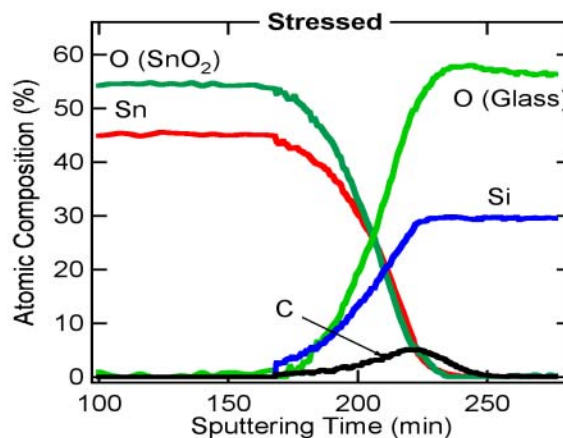
The XPS depth profile of the EPV stressed sample is shown in Figure 4. The sample was stored in desiccant prior to analysis in an attempt to delay or avoid tin oxide delamination. EPV has found that if samples are subjected to the final step of the procedure (humidity exposure), the tin oxide will delaminate. As in Fig. 1, the first 100 minutes of the profile have been truncated. Oxygen 1s peaks and assignments are identical to those of the control sample. The maximum for carbon concentration was found to occur at a slightly higher sputter time than for the control sample, which may be due to slightly different sputtering rates of the instrument since the samples were analyzed several days apart. For comparison purposes, the profiles for Figs. 1 and 4 have been time adjusted to align this carbon peak. As the profile first approaches and then extends into the bulk glass, sodium, magnesium and calcium begin to appear, and eventually, steady state concentrations of these elements as well as silicon and oxygen from glass are reached. Note that sodium, magnesium, and calcium are not shown in the profile.

Figure 4. XPS depth profile of stressed sample

integrity, such as interfacial failure within the SiO_xC_y layer. In fact, additional analyses of EPV delaminated samples were conducted but are not illustrated here.[3] In areas where no visible tin oxide remains, XPS survey scans detected only carbon, silicon, oxygen, and alkali glass metals. Furthermore, depth profiles revealed that the carbon detected was due only negligibly to surface-confined adventitious carbon, since depth profiles revealed steady state carbon concentrations upward of 20 atomic percent for over 20 minutes. These observations are consistent with complete or partial interfacial failure at or within the silicon oxycarbide layer for both this and the sample represented by Fig. 4, respectively.
